This guidance document is prepared for use by Fort Bend County staff, Developers, Engineers, and Contractors to provide understanding and clarity of County pavement requirements for acceptance of public roadways into County Maintenance. The General Acceptance Procedures can be found in the Fort Bend County Regulations of Subdivisions, Section 6 – Acceptance of Improvements within Subdivisions. This document provides guidance on when local, residential pavement can be repaired and when it will be replaced.

Pavement Cracking

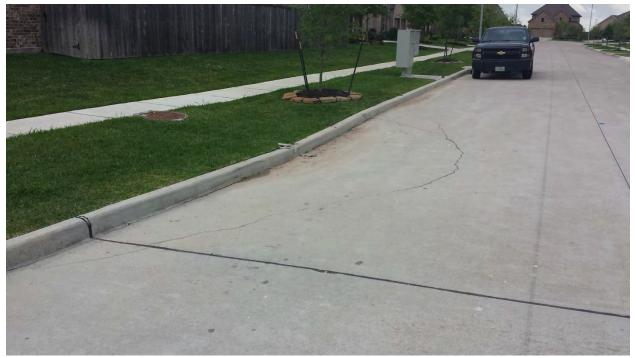
Half-moon cracking is caused by inadequate backfill compaction around manholes. Address utility backfill issue and then remove and replace pavement.

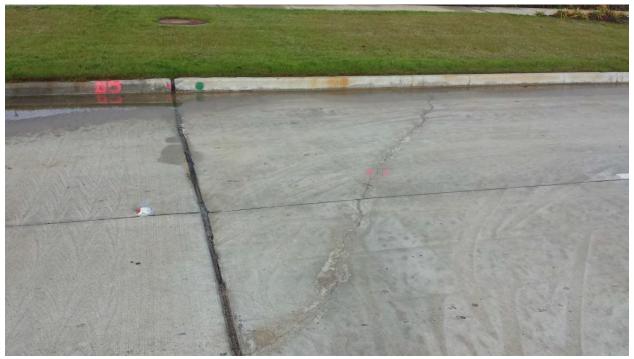
When corner cracking within 10 feet of expansion joint occurs, remove and replace pavement.

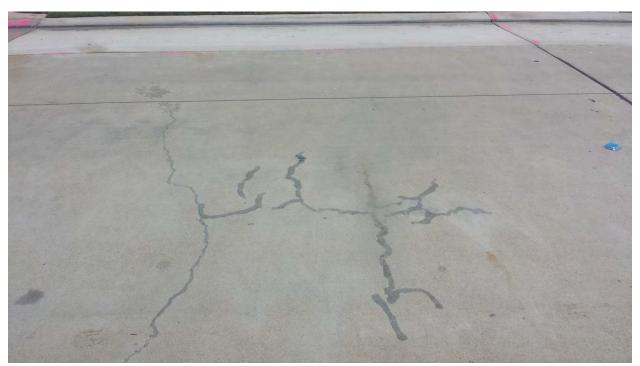
Multiple cracks may be sealed using an approved injected epoxy sealant at the beginning of the one year maintenance period. Panels will be re-evaluated at the end of the maintenance period to determine the effectiveness of this treatment. If minor additional pavement movement has reopened or lengthened cracks, resealing will be required. If there is significant additional cracking or vertical movement is observed, pavement replacement will be required. All sealants must be applied in strict compliance with manufacturer's recommendations.

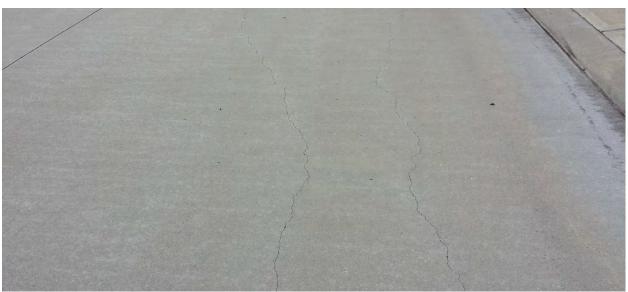
Longitudinal cracks can be sealed under some conditions as long as there is not an associated bird bath. Excessive width, vertical movement at the crack, or associated bird bath will require pavement replacement.

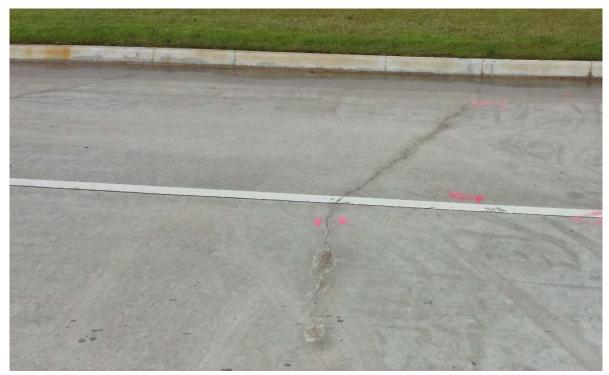
Lateral cracks can be sealed under most conditions. Excessive width, raveling, or vertical movement at the crack will require pavement replacement.

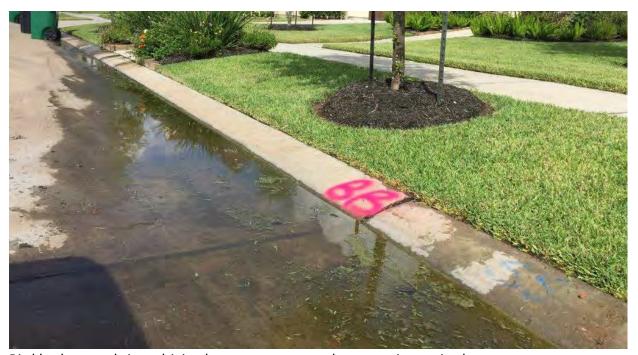
Bird bath extends into driving lane; pavement replacement is required.

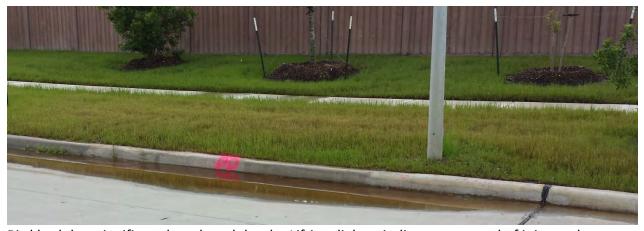
Bird bath has significant length and depth. Lifting, light grinding, or removal of joint sealant obstruction may be acceptable based on field conditions.

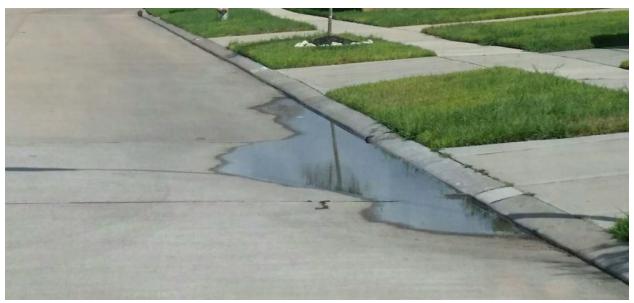
Bird bath has significant length, width, and depth. Lifting or pavement replacement is required.

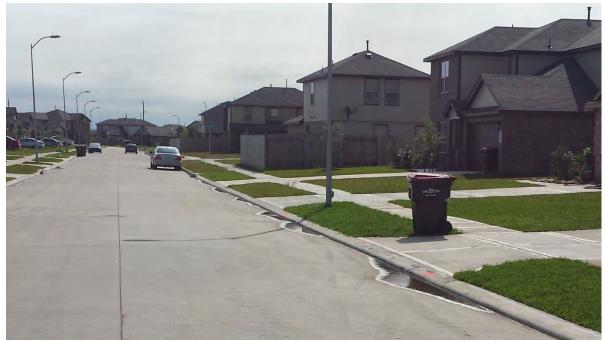
Bird baths which are relatively small in length, width, and depth do not require pavement replacement or lifting. Allowable width is approximately 12 inches. Allowable depth is approximately ¼ inch.

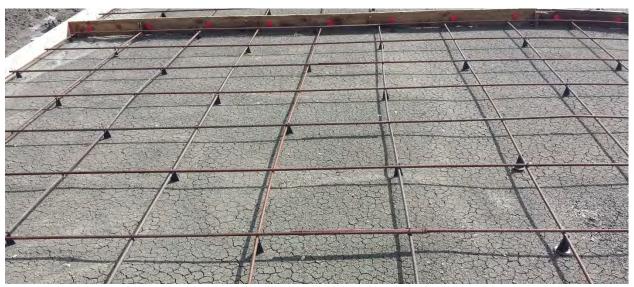
Subgrade is too dry.

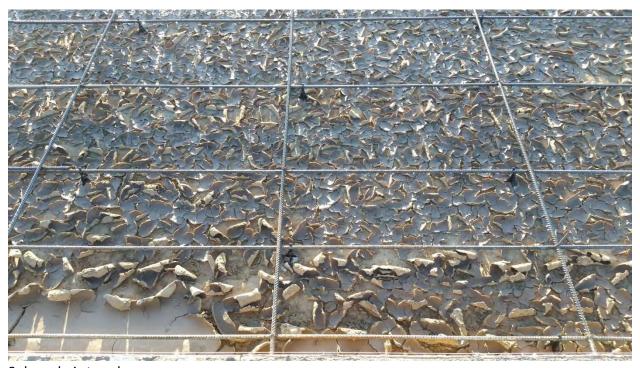
Subgrade is too dry.

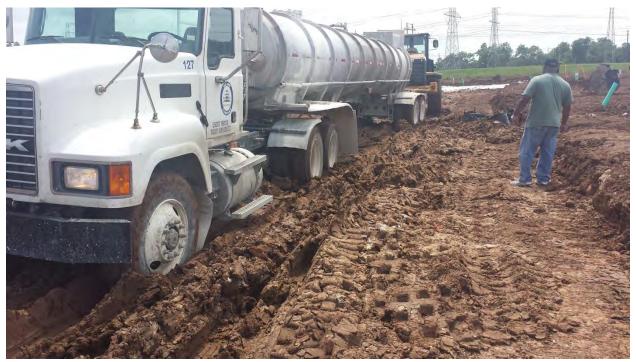
Possible deficiencies in subgrade and base include: Inadequate proof rolling or improper mixing of lime for subgrade, not extending lime mixture to edges of proposed limits of the stabilized subgrade, calculating lime for a 6 inch subgrade and mixing it 8 or more inches deep.

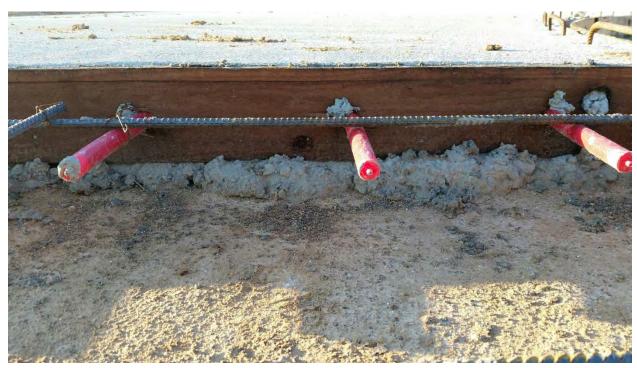
Concrete under headers at expansion joints does not allow expansion to occur correctly.

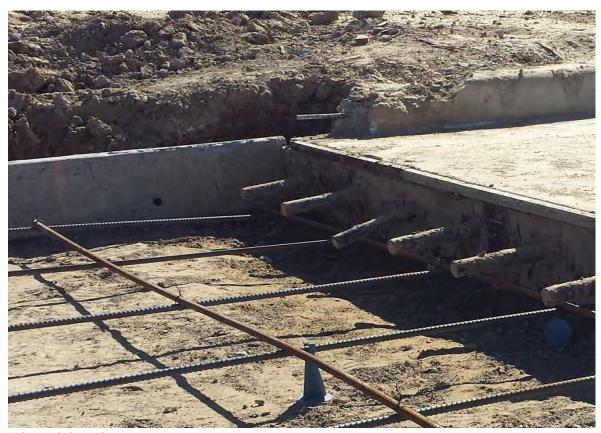
Misaligned dowels

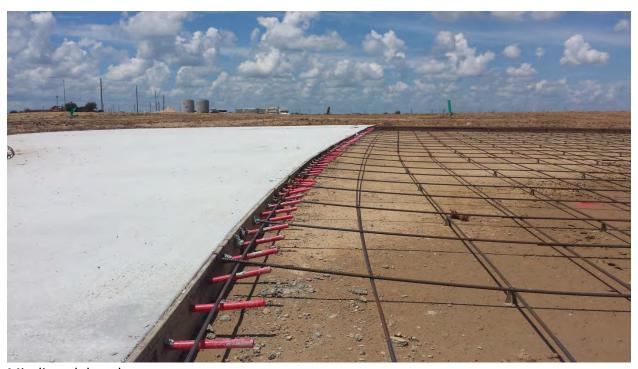
Misaligned dowels

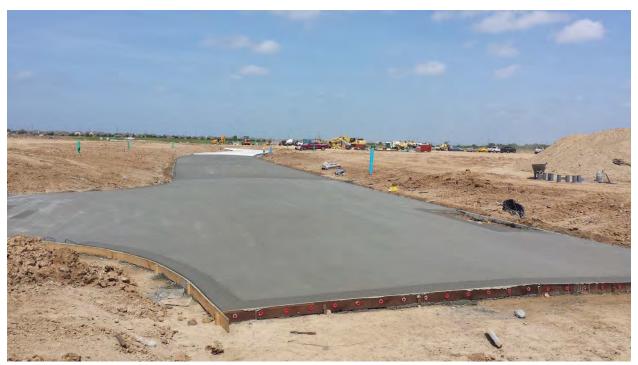
Membrane curing compound not applied to pavement

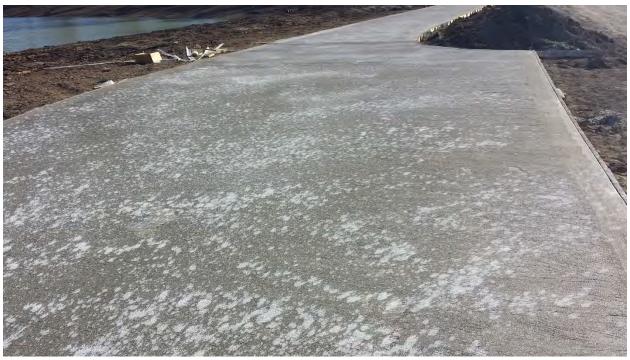
Inadequate curing compound

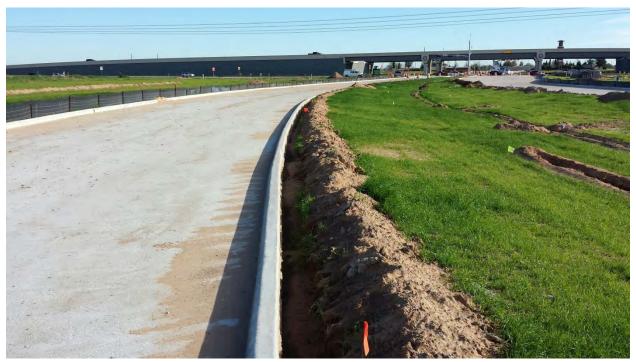
Silt fence or irrigation is placed directly behind curb cuts through subgrade and impacts lateral support.

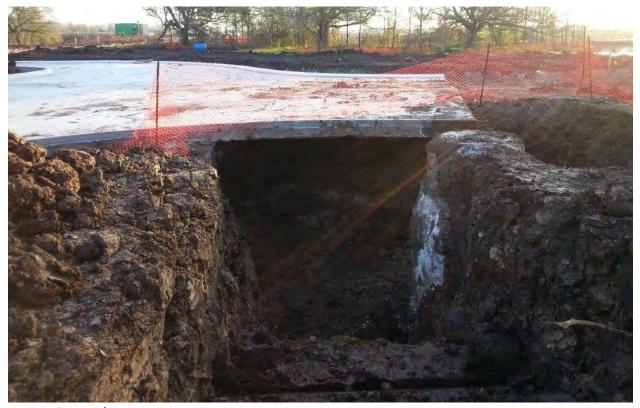
Excavation under or near pavement

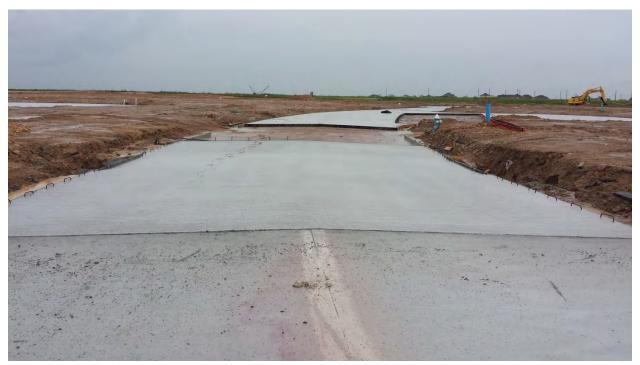
Not saw cutting within specified time (photo shows 4 day old concrete with no sawcuts)

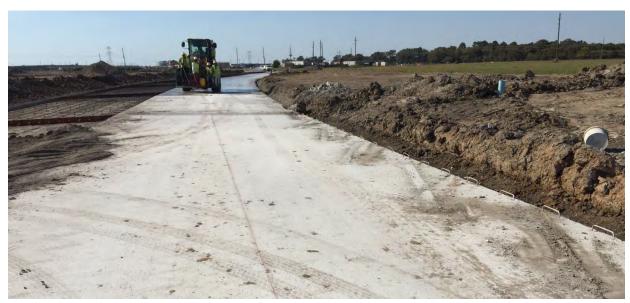
Equipment operating on pavement with inadequate cure time
